# Manhole Inspection Summary

Manhole # S37E\_\_030MH

Insp Date: **11/18/08 10:43 AM**

**Location** Address: **side 500 e lexington st**

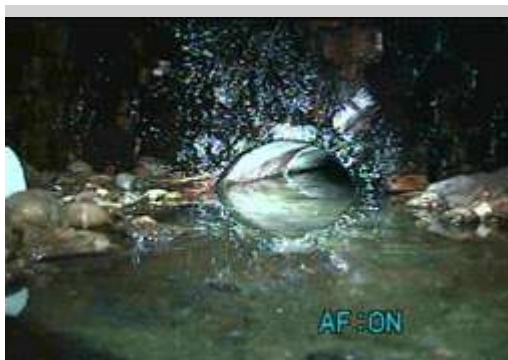
Defect 5

Condition: ☐ Sound ☐ Cracked ☐ Root Intrusion ☐ Deteriorated ☐ Leaks ☒ **Debris**

channel debris

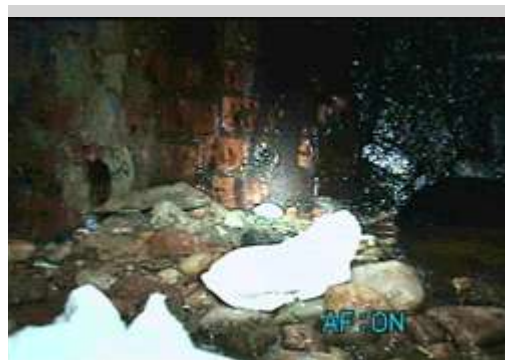
Defect 4

bench debris

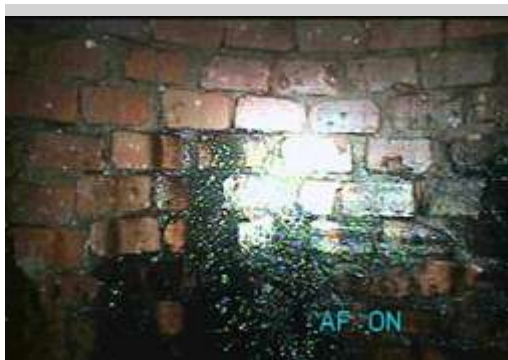
Defect 3

Infiltration: ☐ None ☐ Joint ☐ Cracks ☐ Mortar ☐ Roots ☒ **Wall**

barrel infiltration

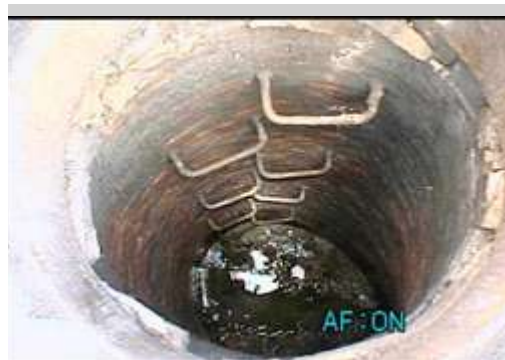
Defect 2

**Steps** Count: **8** Missing: **0** ☒ **Corroded**

corr steps

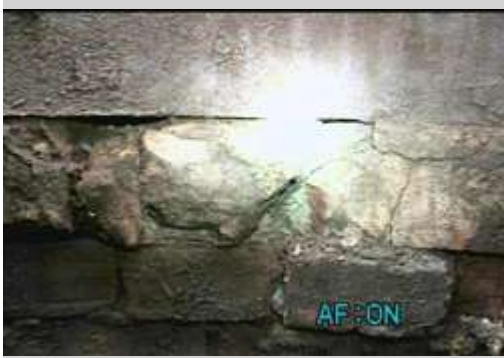
## Defect 1

Condition: ☐ Sound ☒ **Cracked** ☐ Root Intrusion ☒ **Loose Brick** ☒ **Deteriorated**

chimney cracked and losoe bricks, frame  
adj
